| <b>ENGINEERING REPORT</b> | <b>Report #</b> | CE23-0606 |
| <b>Evaluation of R-VPX product to VITA 72<br/>vibration levels</b> | <b>Revision #:</b> | <b>A</b> |

Testing was performed on Amphenol's R-VPX Ruggedized VITA 46 connector to determine its ability to withstand VITA 72 vibration levels.

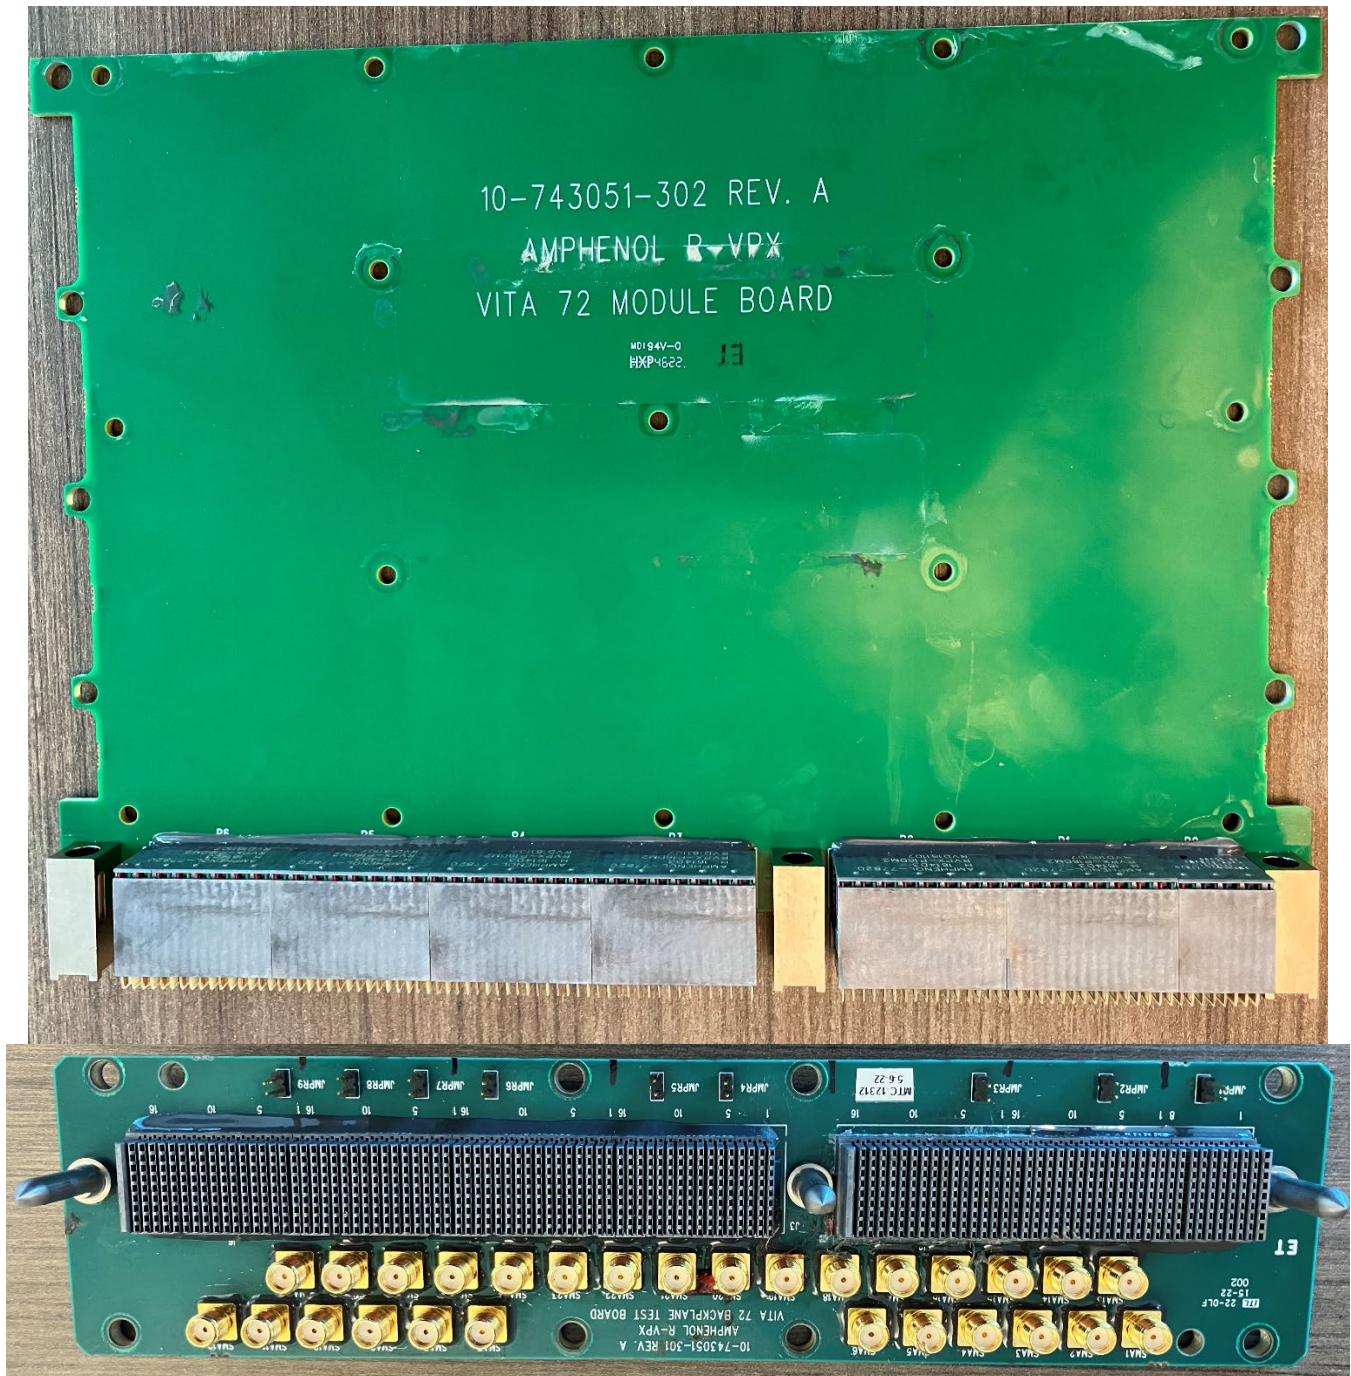
Figure 1: Typical Test Sample

Test specimens were taken from normal production lots. Specimens identified with the following part numbers were used for test. Testing was performed on 50 µin gold parts.

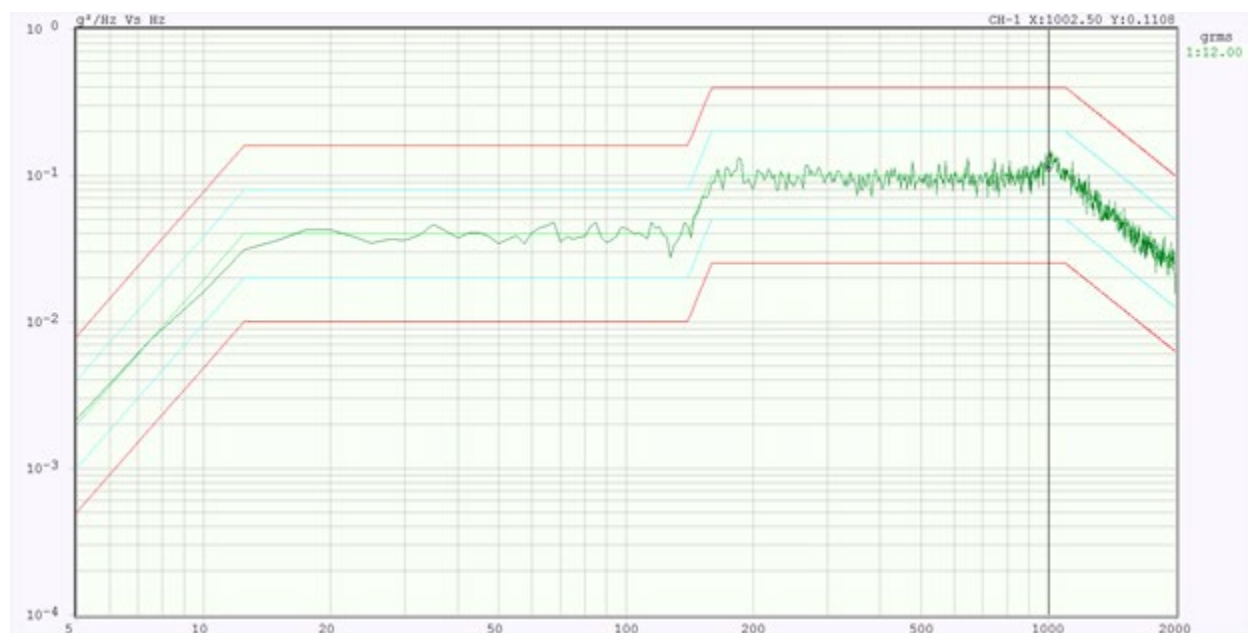
**Random**

Broad Band Random

Test duration 1 hours 0 minutes.

Test performed in each of three mutual perpendicular axes.

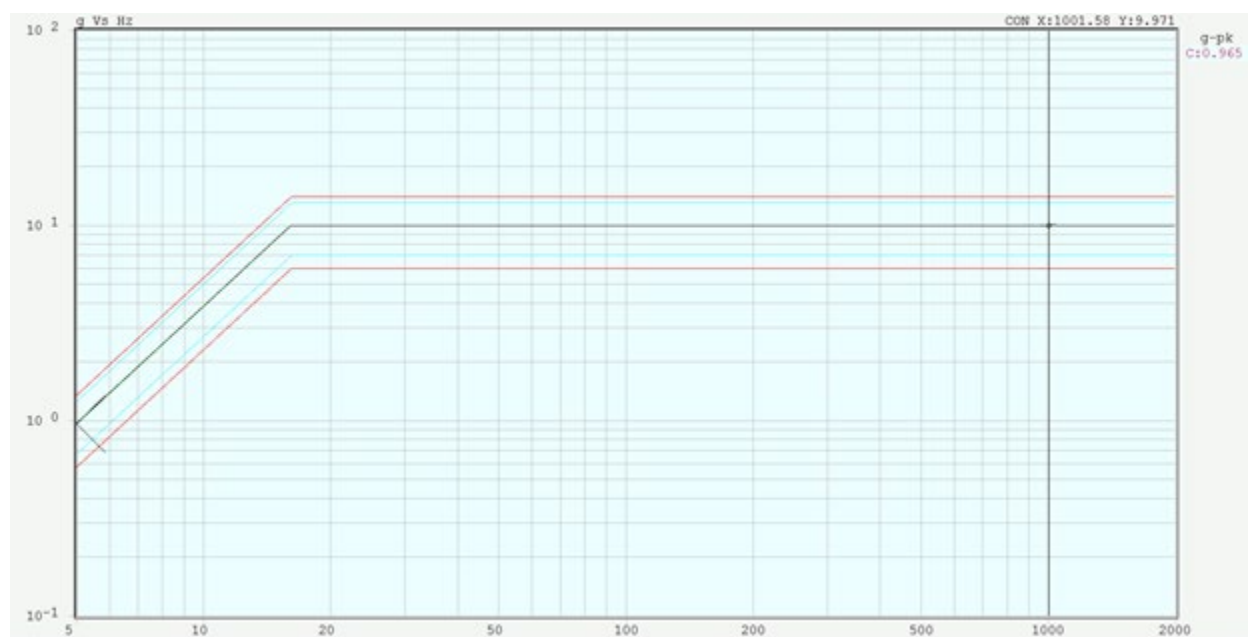
**Sine**

Swept Sine, sweep time 10 minutes, from 5 to 2000 hertz.

Test duration 1 hours 0 minutes.

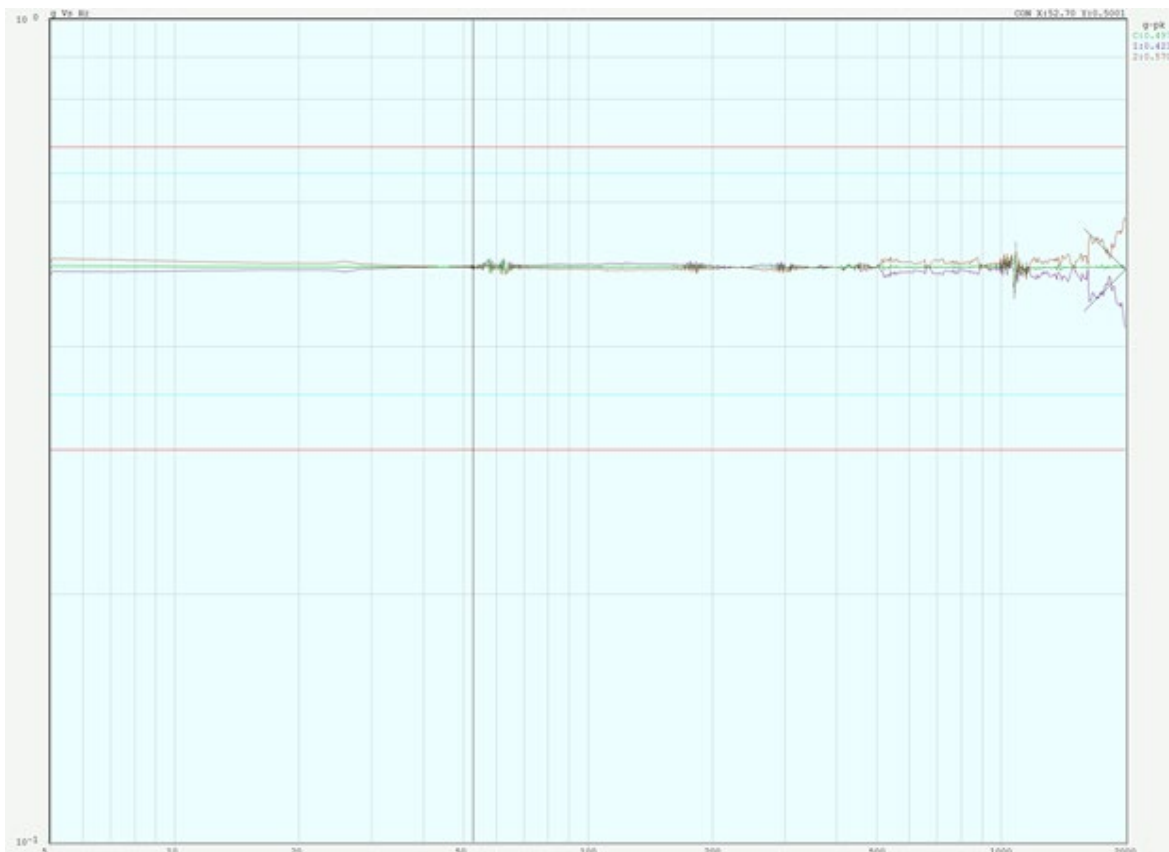
X axis Sine Sweep Whole assembly

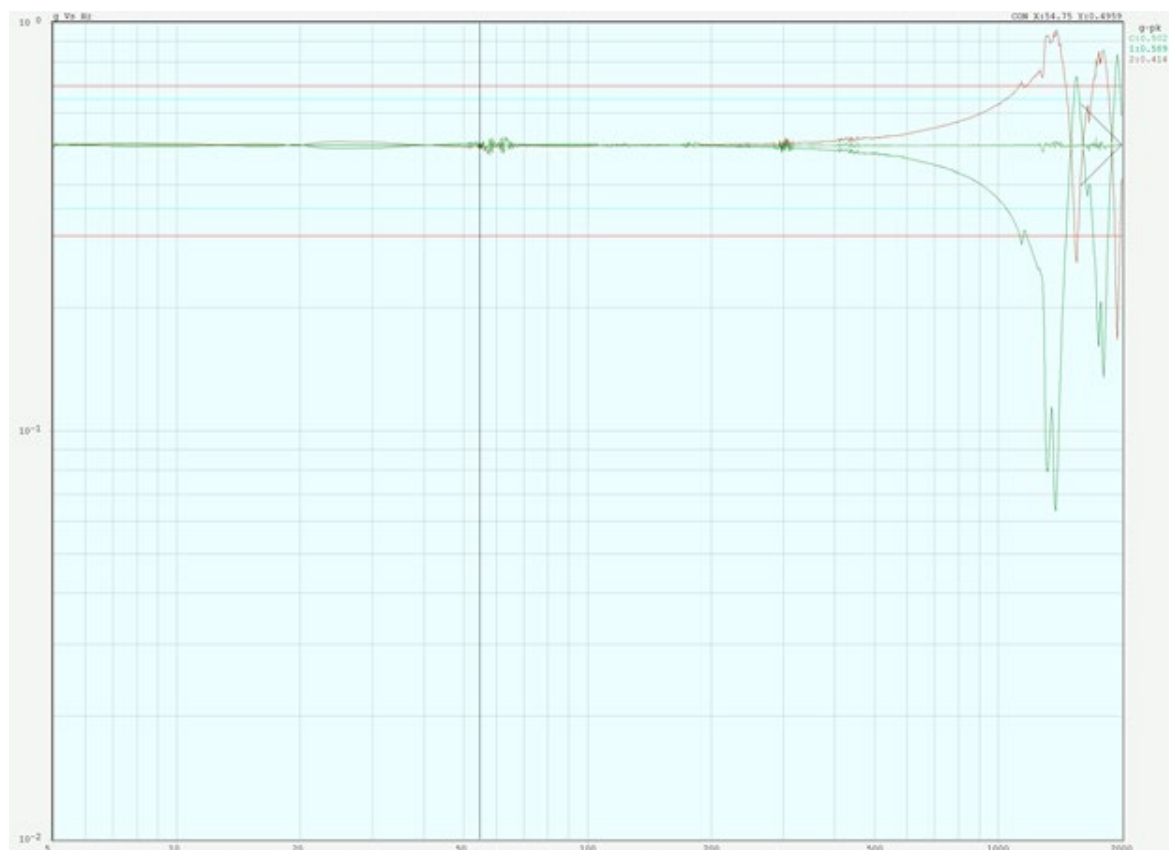
Z axis sine sweep with just the fixture

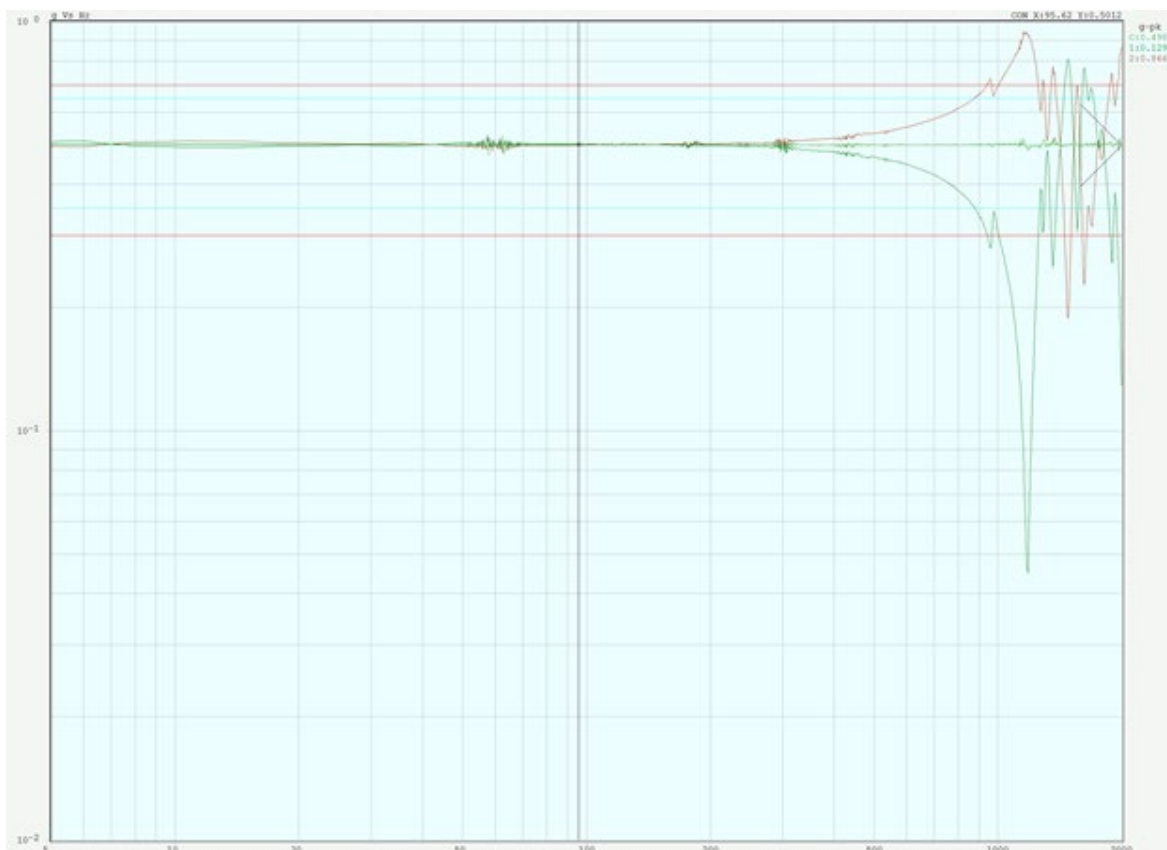
Z axis Sine Sweep with fixture and backplane

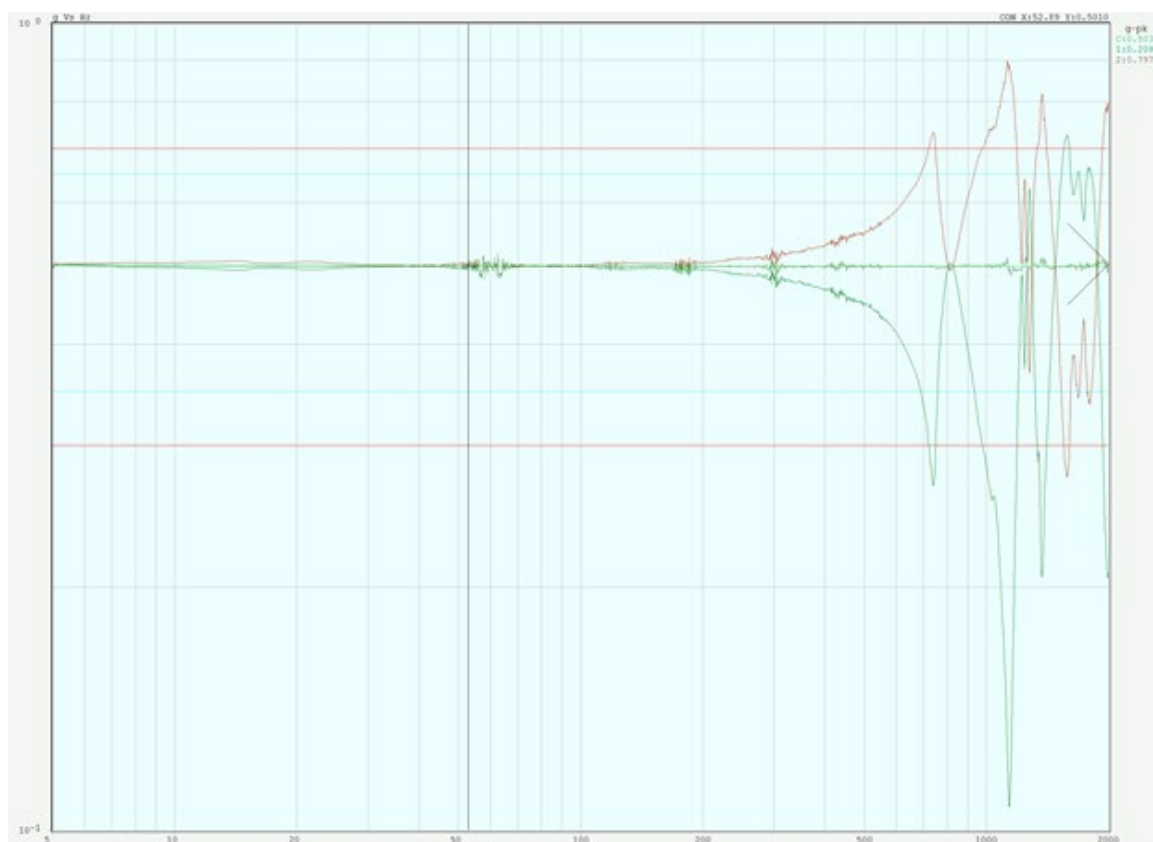
Z axis sine sweep fixture, backplane and cables

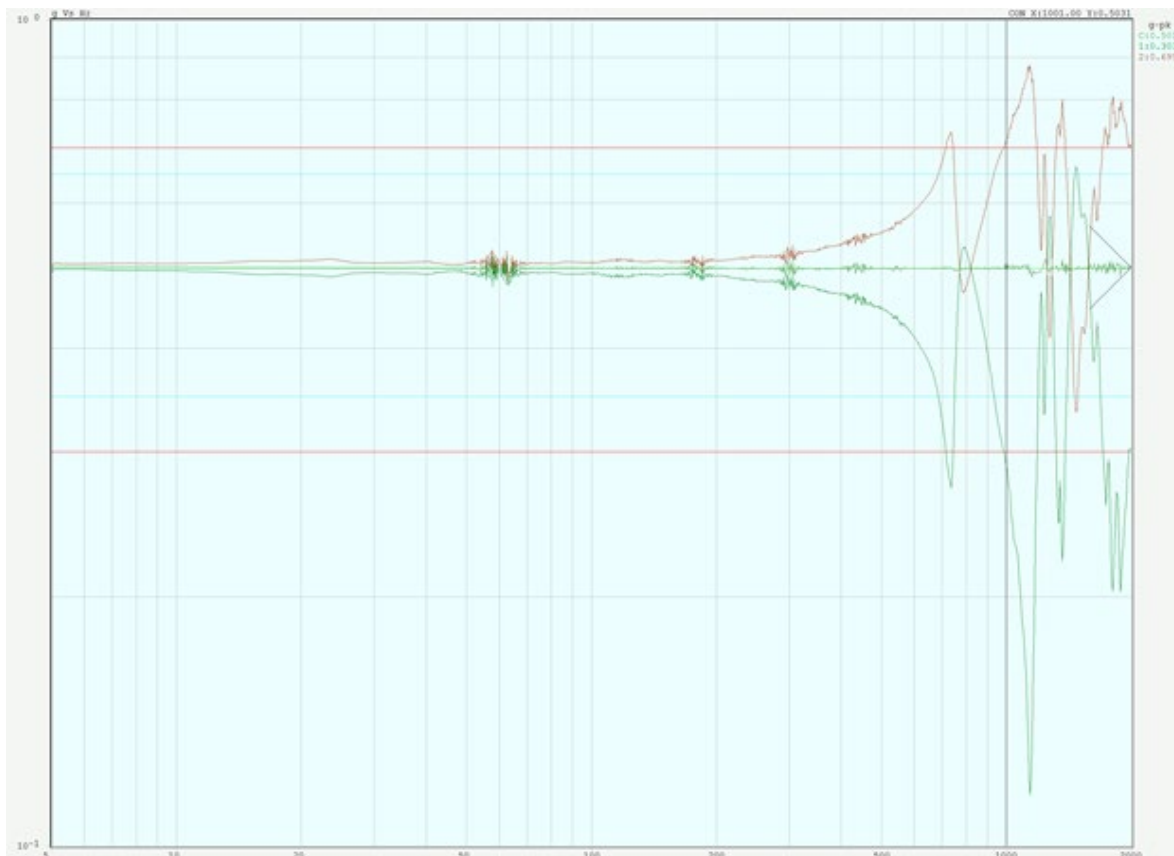
Z axis with whole assembly

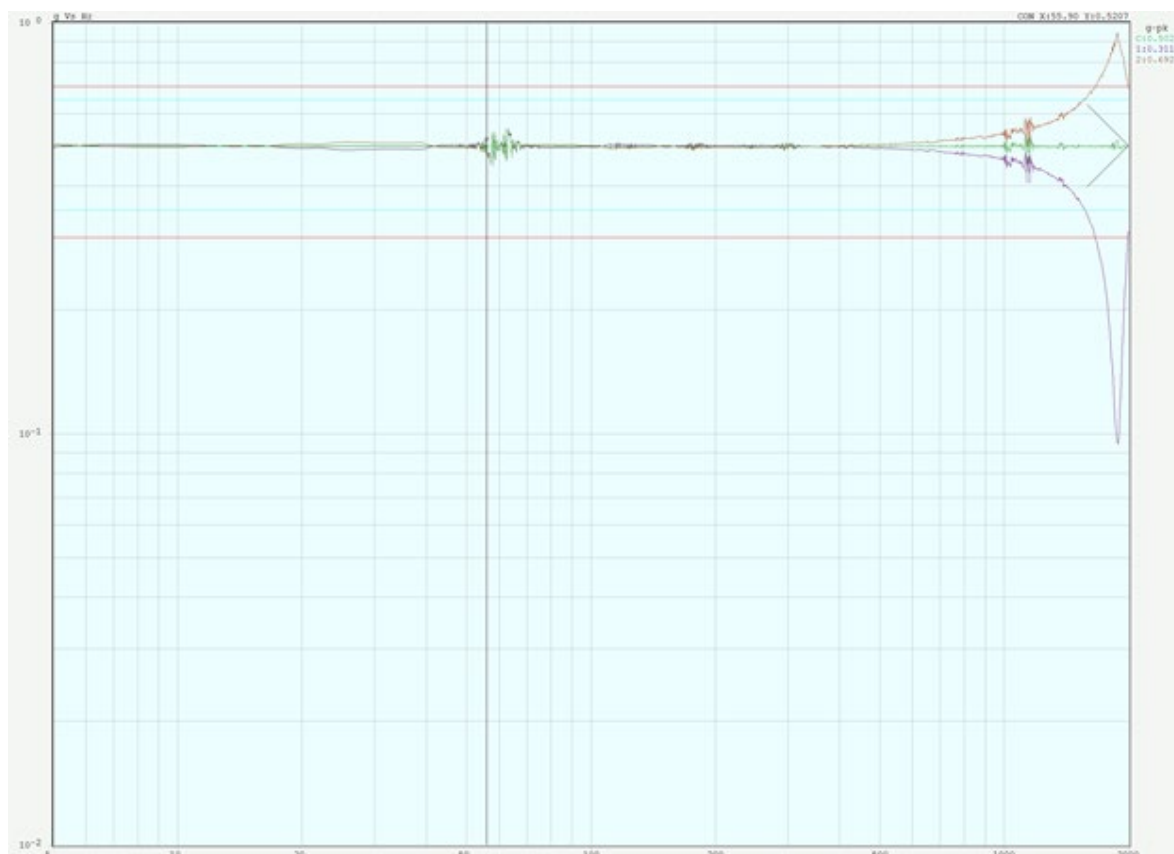
Y axis sine sweep bare fixture

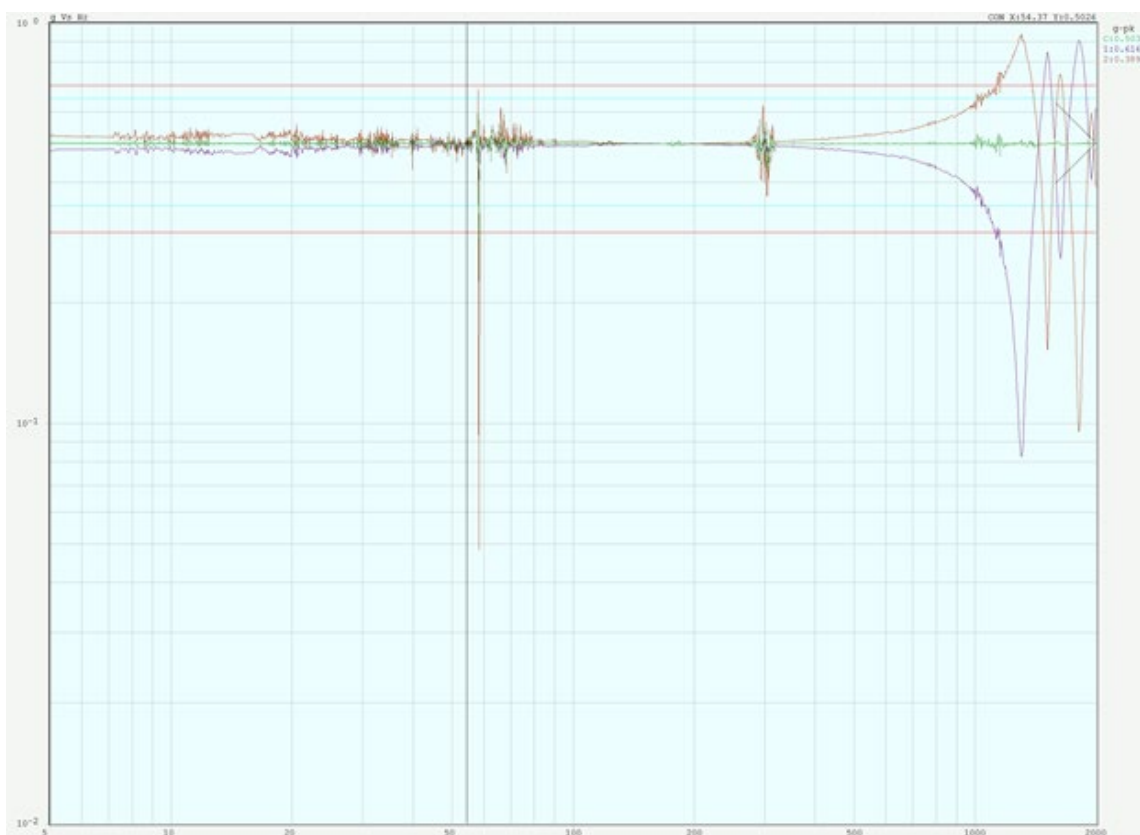
Y axis sine sweep with fixture back plane and cables
